## **KEÇİÇAYIRI: AN EARLY BRONZE AGE II FORTIFIED HILLTOP SETTLEMENT (NORTHWEST ANATOLIA)**

The article deals with the architecture of the Early Bronze Age II fortified hill-top settlement of Keçiçayırı, located in the eastern Phrygian Highlands (north-western Turkey). Measuring ca 130 x 100m, the settlement is established on a flat surface on top of a hillock known as Cıbrada, with the fortification wall closely following the external contours of Cıbrada. The row-houses, connected to the fortification wall at the rear often have shallow porches at the front, which open onto a possible central courtyard. The site is of great importance as it shows the existence of fortified settlements in the highlands of the Eskişehir region, already around the middle of the third millennium BC and possibly in connection with intensified trade relations between distant areas. The settlement of Keçiçayırı, which currently represents the only known example of these settlements, may have been built to manage and protect sources of raw materials like flint.

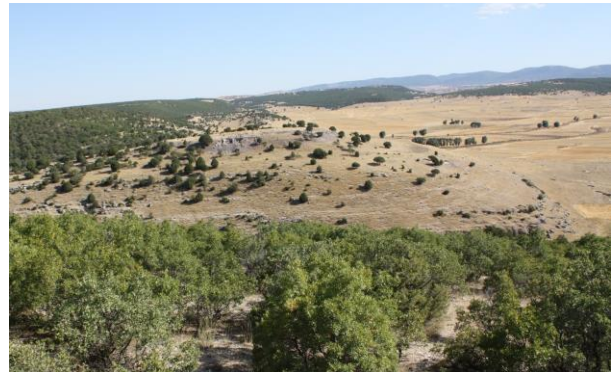
Figure 2. Excavations on the Cıbrada Hillcock, from the north

archaeological levels pertaining to the Early Neolithic, Late Chalcolithic, late EBA II, early EBA III, Roman, and Early Byzantine periods (Efe et al, 2011: 9). These excavations were carried out in four separate areas, namely the "Höyük" (Mound), the "Northwest Fields", the "Terrace" and "Cıbrada", a small hillcock with flat top rising ca 50m above the valley bottom; archaeological investigations mostly focused on Cıbrada (Efe, Türkteki 2007: 76) (Fig. 3).

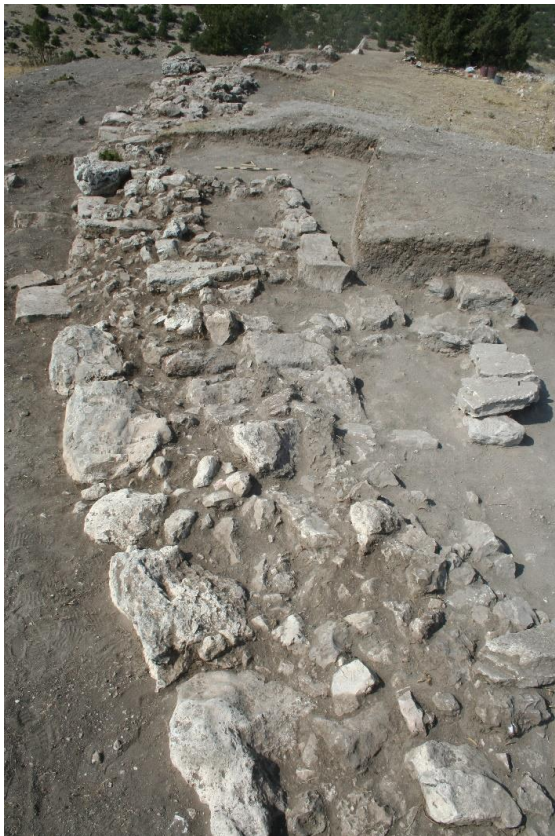
Figure 7. Fortification wall and the houses built against it in the western section

In the west of the settlement, excavations have been carried out in grids AT 9, AU 9, AS-AT 8, AV 8, AS 7, AS 6 and AS-AT 4-5. Furthermore, in the north-western section, the defensive wall has been documented through cleaning works in grids AS 3-4, AT 2-3, AT/AV 2 and AV 1-2. From the destroyed south-western section of the settlement to the western section towards the north, thirteen rooms, including the gate, have been determined. These rooms have been numbered consecutively from south to north (Fig. 6). In this section the fortification wall and houses adjacent to this wall have been uncovered (Figs. 7-9). The majority of the front sections of these single-roomed houses that open onto a possible courtyard in the centre of the settlement have not been excavated. It is thought that the two southernmost buildings in this section were each formed of two rooms. We can assume that the other buildings are formed of a single room and a porch, as seen in the examples whose front parts were also excavated in the north (rooms 14-16).

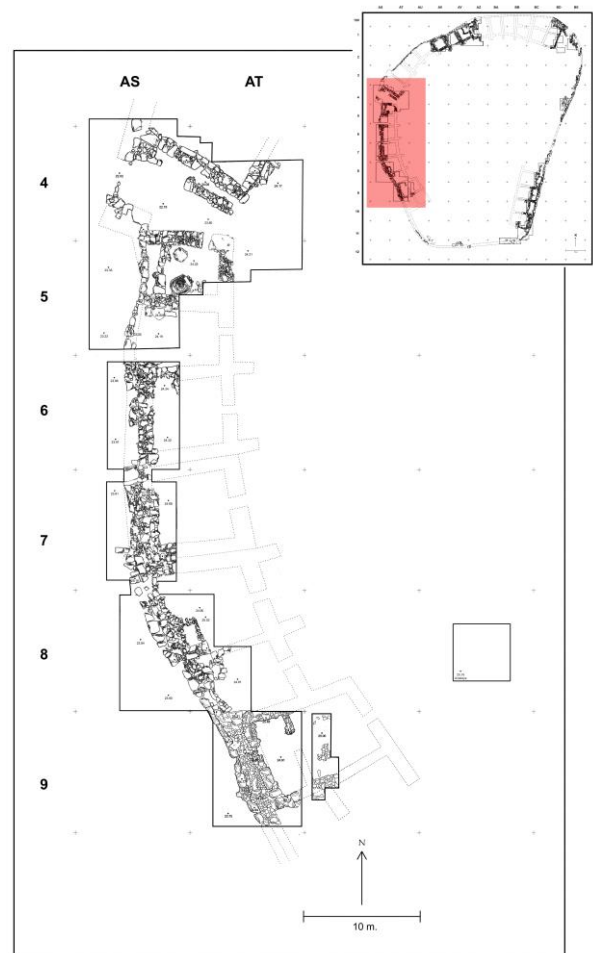
Figure 8. Drawing of the architectural remains in the western section

In the southernmost part of the western section, only the northern sidewall of rooms 1a and 1b have been uncovered. This wall was used jointly as the south wall of rooms 2a and 2b to the north of the building. During the work carried out on the front

Here, the gaps between the rear walls of the houses and the fortification walls were not filled with small stones as they were in the south. We can therefore conclude that the buildings from here to the northern section were constructed adjacent to the fortification wall. A silo was uncovered in the northwest corner of room 4. Room 5, measuring 6.0 x 5.4m, is adjacent to this room from the north. Here, the fortification wall corresponding to this room is

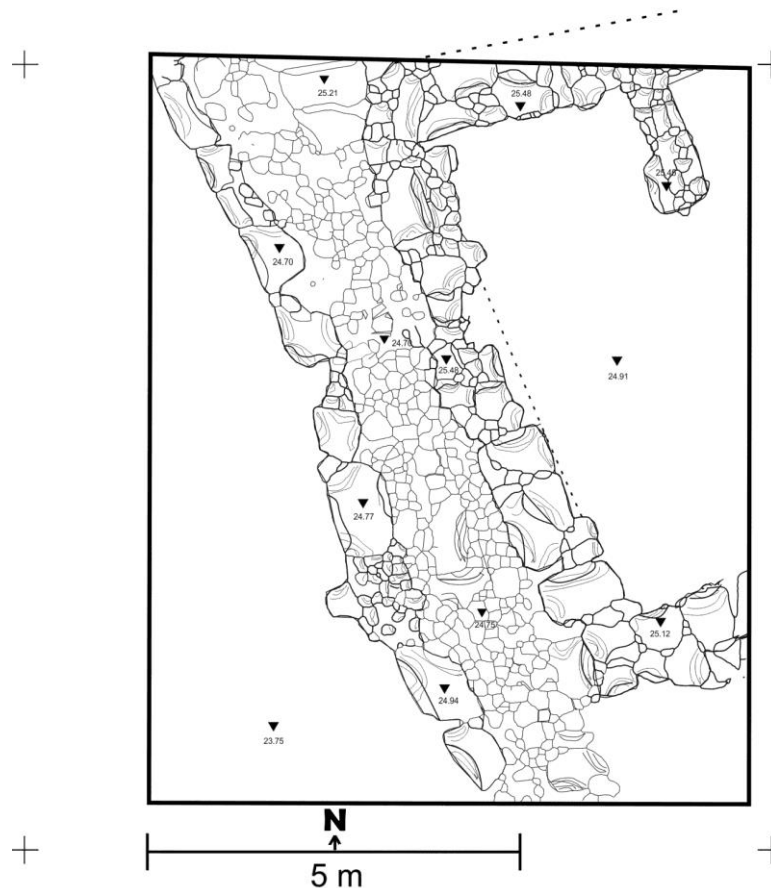
Figure 9. Fortification wall and part of the house built against it in Trench AT 9

tion of the fortification wall that coincides with the rear of room 7 appears weaker than in other sections. To the north of this room, a long, thin corridor-shaped room (room 8b) was uncovered inside the fortification walls, and to the east of this corridor a rectangular room with an oven was uncovered (room 8a). Heavily burnt mudbrick rubble shows that these two rooms also suffered serious fire damage.

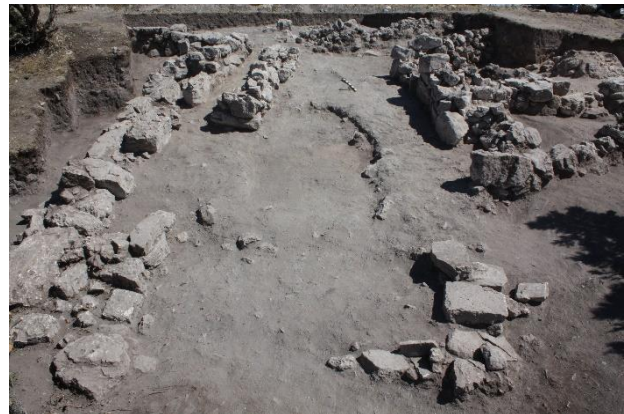
Figure 10. Western Gate, from the west

The settlement's "Western Gate" is located where the slope decreases slightly, at the end of the natural terrace that rises from the bottom of the western slope (room no. 9, Figs. 10-11). The gate opening measures 5m and is delimited by two thick opposing walls. These two walls join the body of the fortification wall from the south and north, and approach each other slightly in the east in order to form the entrance of the interior gate. The pile of stones found at the front entrance of the partially ruined gate show that two facing towers may have been placed at each side. The gate room is reached from the front entrance, which is set out a little from the body of the wall. The recess in the north-western corner of the gate room may belong to a staircase landing used to reach the upper floor of the tower.

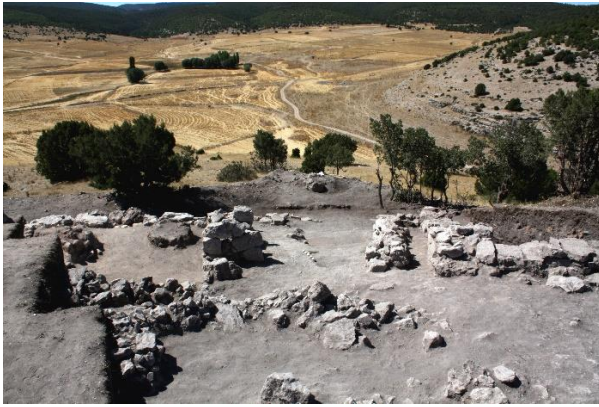
Figure 11. Western Gate, from the east

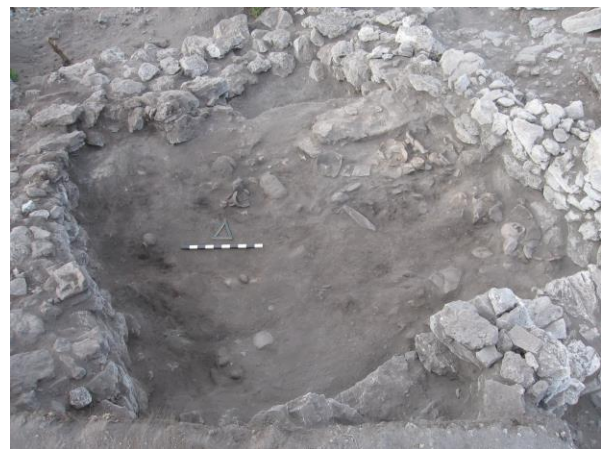
Figure 12. Burnt room 16 in the northern section with *in situ* finds.

Located to the east of room 15, room 16 was severely burnt like the other rooms in this section, and all the deposit here has been excavated, bringing important finds (Fig. 12). In the north-eastern quarter of the room, a separate cell-type chamber was uncovered, delimited by small stones slabs, placed immediately on the floor. The northern side of this chamber is enclosed by the body of the fortification wall. The western and southern walls of the chamber must have also served as supporting walls for the upper floor of the house. The walls of the house measure approximately 1m in width and the floor has a steep slope; the fact that the pieces of some of

the vessels are spread over a large area gives the impression that they may have fallen from an upper floor, suggesting that these houses had basements. The difference in height of the floor between the north and south is approximately 1.3m. The entrance to this room opens onto a terrace cut into the bed-rock. This room has an area of 27m<sup>2</sup>, and here almost every variety of finds that could be found in an Early Bronze Age settlement was recovered *in situ* in a single room, concentrated along the room's eastern wall. As well as over forty pieces of restorable pottery, the finds included marble idols, animal figu-

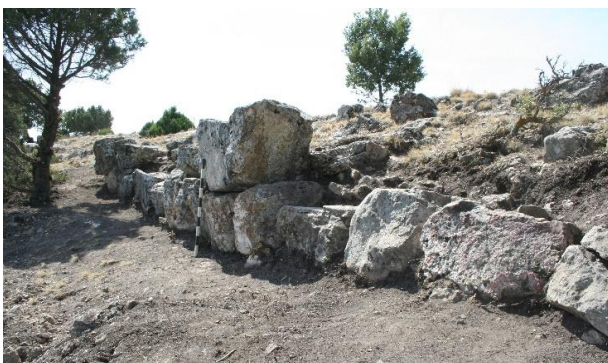
Figure 14. Outer stone row of the fortification wall in Trench BD-BE 4-5

The fortification wall has thus been almost fully uncovered in the eastern section (Fig. 14-15). The remains of buildings were exposed in the south-eastern section, and it is thought that one of the gates of the settlement may have been located at the north-eastern end. However, due to destruction over an extended area, it is not certain whether or not a gate existed here. As stated above, since the fortification wall is wider on both sides of the ruined section, there is a high possibility that a gate was located here. Here, a wall built perpendicular to the fortification wall stands on the bedrock and was built prior to the fortification wall. We cannot say with certainty whether or not this wall remained in use after the construction of the fortification wall. To the west of the destroyed section, the fortification wall is formed of four rows of stones. The gaps between these are again filled with stone chippings. A wall measuring 9 m in length was uncovered to the west of the pos-

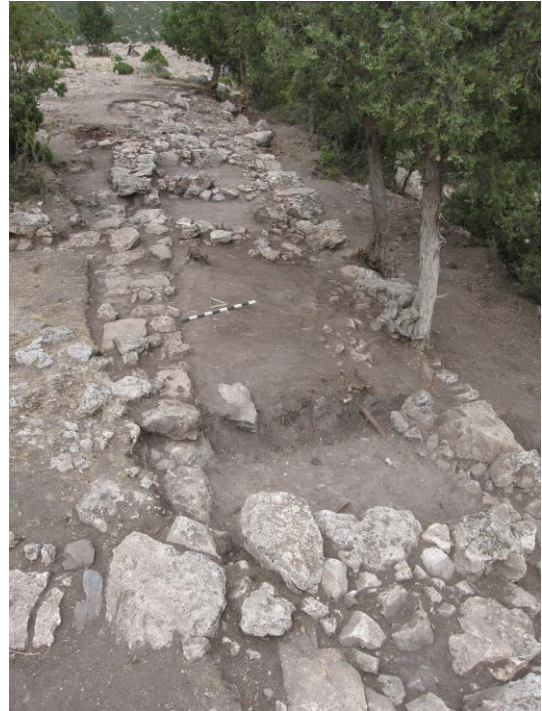
Figure 16. Row-houses along the fortification wall and possible silos in the eastern section, from the south.

From this section, we can trace the fortification wall, which is built of very large clear-cut stone blocks, running south for approximately 60m (Figs. 16, 17). Here we also see that in some places huge outcroppings of bedrock were included in the body of the fortification wall. Four of the five houses partly exposed in the southeast of the settlement (numbers 22a-b, 23a-b, 24a-b and 25a-b) have small cell-like rooms (cubicles) at their backs. The house in the south has two rooms (numbers 25a-25b) without cubicles. Large sherds from a pithos have been found in cell 22b behind room 22a. There are two cubicles (numbers 23b and 23c) behind room 23a, with a door for traffic between them. A beak-spouted jug has been recovered in the deposit of cubicle 23a. The rectangular cubicle of the third house (no. 24b) is larger than those of the others.

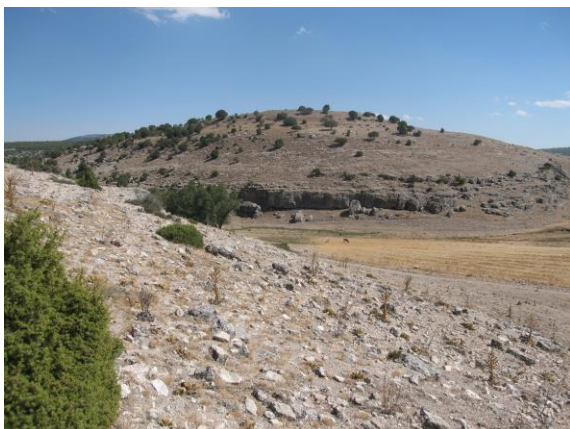
Figure 18. Flint quarries around Cibirada

contours of the Cibirada Hill, where the settlement is located. We can see that, in the eastern and south-eastern section, the walls were built into the deposit of the previous level, while in other sections the lowest row of stones was placed directly on the bedrock. According to geologist Prof. E. Altunel, who carried out investigations at the site, the large blocks of limestone used for the external façade of the walls and the small and medium-sized limestone rocks used in the walls of buildings were taken from limestone layers on the slopes of Cibirada. Thanks to naturally-formed horizontal and vertical cracks, the stone blocks were removed from their stratum with no need for cutting and were used in the settlement with no further shaping. Also flintstone lenses between stratified limestones in the bedrock were detected by geologist Prof. E. Altunel. These layers of flintstone are located on a ridge northeast of the settlement, and were certainly quarried during the prehistoric times, as indicated by the abundance of working debris, flakes and some prismatic cores scattered in the area (Fig. 18-19).

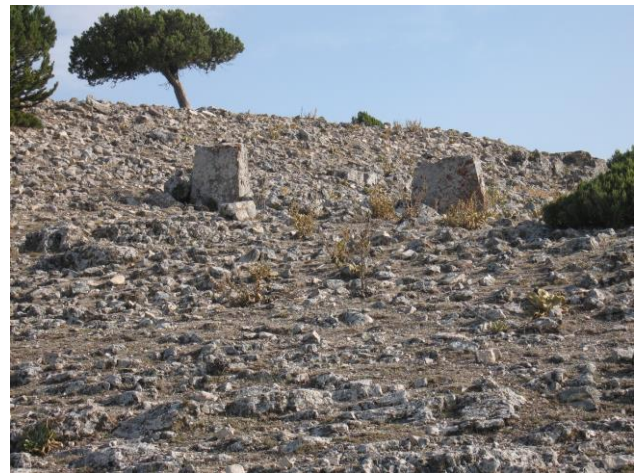
Figure 19. Flint quarries on the Cibirada
