# SLOPE STABILITY ANALYSIS METHOD OF ACCOUNT BACK AND EXAMINATION OF TEKKE LANDSLIDE WITH BACK ANALYSIS METHOD

**Mümin FILIZ**

**Semiha GÖKCAN**

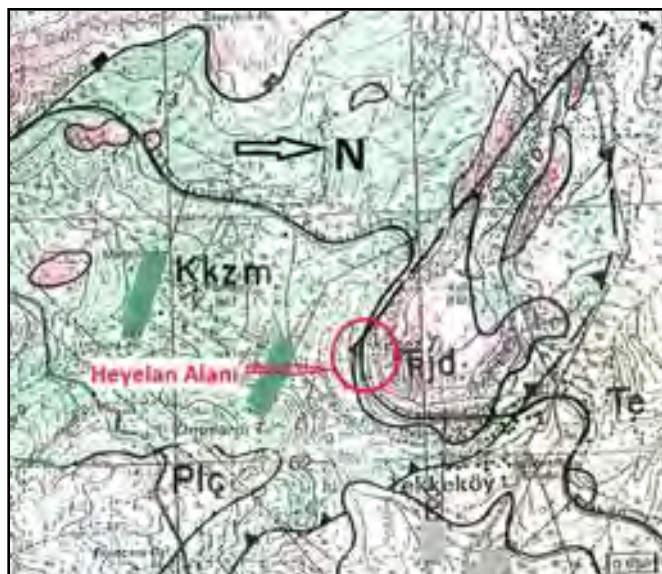
Figure 1. 1/25000 scale Geology Map of the project area and the environment

The formations commonly seen in the region belong to vairouspeoriodes of mesozoic and tesierpeirods. Quaternary storages take place in the lower areas of the region. (Figure. 1)

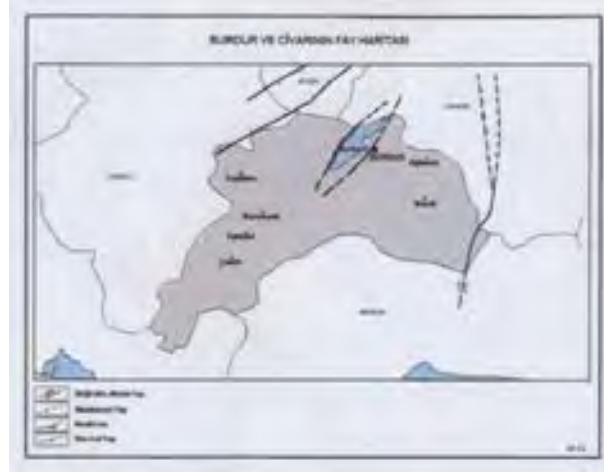
Figure 2. The constructional map of the area

The city of Burdur is located over Burdur plate zone which is one of the most active plates in the West Anatolia. (Figure 2). Within the years of 1914, 1957 and 1971 various major earthquakes between the sizes of 6.1 – 7.1 occurred in the area. The distance of the underground water from the surface is of a great importance within the areas enjoying first degree earthquake risk because of the deflation of the surface.

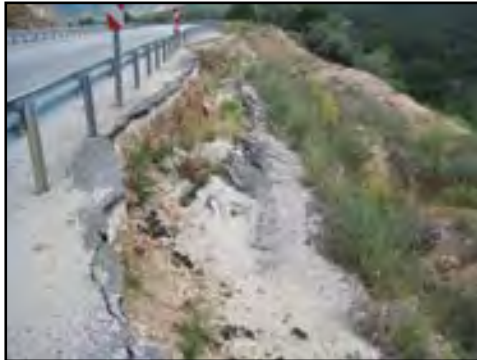
*Figure 4. The Landslide and the deformations*

Tekke landslide occurred in Burdur-Antalya highway KM: 99+200. As it can be seen from the photographs and the section of the landslide chamber slope is about 30 degrees (Figure. 4). The chamber angles that have

slided and settled on the filling are below 30 degrees. In the geotechnical department these materials have been named as colluvial and way fillings. The angle of the chamfer slopes from the wall that has moved towards the valley grounds go until 35 degrees. This material has been defined as Bresh. On the other side of the highway there is a steep drop-off with 40-45 degrees structured with limestone (Figure.5). The existing chamfer slopes provides useful data about the endurance of the material.

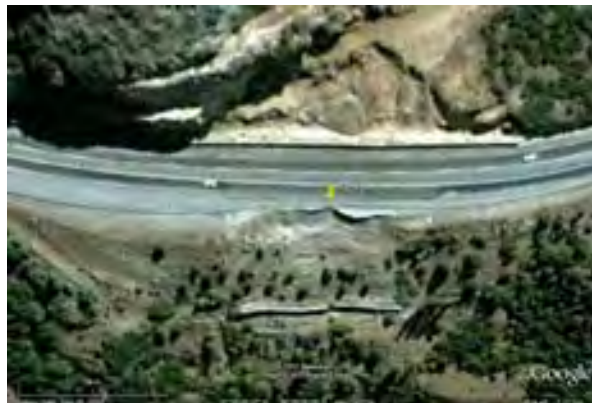
*Figure 6.The satellite photo of the landslide in 2003.*

The satellite photographs of the landslide provides important ideas about the shape and the reasons of the landslide. In the photo in year 2003 (Figure 6) we understand that the highway has three lines and there is a landslide in the 15-20 mt of the chamfer towards the valley grounds moving the fillings. In the photograph that belongs to year 2006 (Figure 7) we see that the part that slided has been repaired with a 30 degree filling. The 2010 (Figure8) photograph shows we can see that the repaired filling slipped. In Figure11 the the borders of the estimated filling is shown with red lines. Upon analysing the photographs we can clearly see that the 2-3 mt high wall underneath the chamfer has started to lose its stability in the 2003 landslide. When comparing 2006 and 2010 photographs the filling and the wall side of the filling has moved clearly. All these datas indicate that the sliding mechanism occurred in complex (mix) surface.

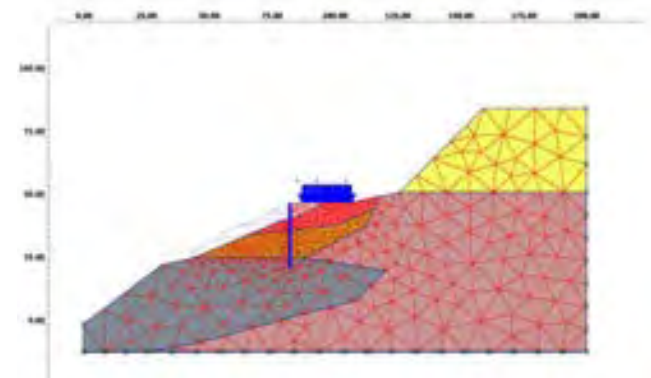
Table 13. Second loading situation

The situation of the wall under the chamfer that loses its endurance and falls down (Table13)
