The Restitution and Design Principles of Beylerbeyi Palace Gardens, Istanbul

ABSTRACT

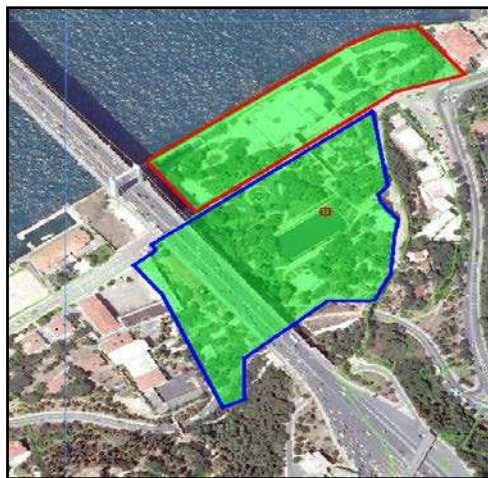
Figure 3. Beylerbeyi Palace Land "Uskudar, 1133 islands, 14 parcels-red border; 1333 island, 47 parcel-Blue border " (Kuzucuoğlu, 2011)

22.016 m2 of the area where the main building of Beylerbeyi Palace gardens is located at Uskudar district, 122 plot, 1333 block, 14 parcel and the terrace gardens of 40.869 m2 including Mermer, Sari and Ahir mansions are located in 1333 block, 47 parcels as registered in the name of Treasury of Finance. All structures of Beylerbeyi Palace Gardens are positioned independently and in an unsymmetrical manner in the land. The main structure of the palace is located on the shore while the other buildings are built in terraces gardens according to their functions. Beylerbeyi Palace gardens have a different set up in terms of their general design features in comparison to other palace gardens in terms of their coastal mansions and gardens or terrace gardens. The gardens between the palace mass (main building) and the sea are designed in a more formal way and having more general use; the terraces gardens located on the upper level are designed for more special uses. Some of the terrace gardens have geometric partitions; while the terraces on the higher side are more informal (Aliasghari Khabbazi, 2016). The main building of the Beylerbeyi Palace Gardens, built as a summer palace, was used for management, living, hosting and representation of foreign guests; Sari mansion, Serdab mansion and Deniz mansions were used for resting purposes; and Ahir mansion was built for palace horses and caretakers. I. Abdulhamid Primary School, I. Abdulhamid Imaret Kitchen, Barracks, and Wreaths, Kalfalar Building and Kizlaragasi buildings do not exist today.

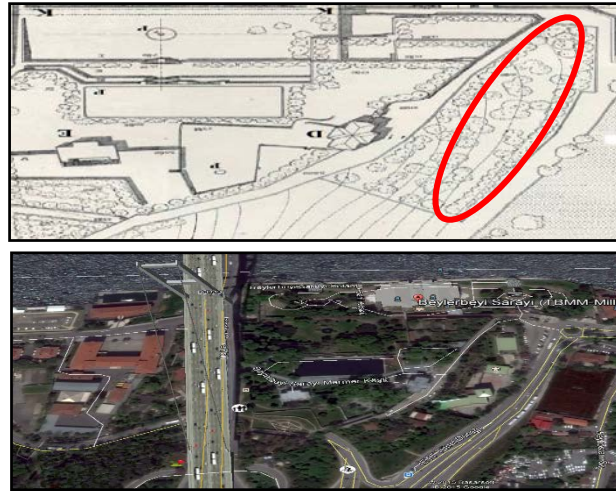
Figure 10. The green area situated between Abdullahaga Avenue and Sahbaz Street in 1900s (Eldem, 1976)

Figure 11. Current status of the green area between Abdullahaga Avenue and Sahbaz Street (Aliasghari Khabbazi 2016).

The southern side of the fourth terrace garden of Beylerbeyi Palace grounds faces Sahbaz Yigit Street, the roadway gate. The area between Abdullahaga Avenue and Sahbaz Street where Beylerbeyi Palace is located is stated as a green area according to maps and photographs taken in 1900's. Today, Turkey Soccer Federation Administrative Building, Turkey Soccer Federation guesthouse, a parking lot and Beylerbeyisi Haci Sabanci High School are located in this area. Based on the data obtained from photographs and maps of 1900s of Beylerbeyi Palace gardens, the green area opposite the Harem garden wall is Istavroz Meadow. Today, this area is divided into two sections with Beybostan Street. There is Beybostan villas in the eastern part, and Beylerbeyi Palace Boutique, a parking lot, Rumeli Bakery and Beylerbeyi Elementary School are situated in the western part. Bostancibasi Abdullahaga Mosque still exists today since its original construction date.

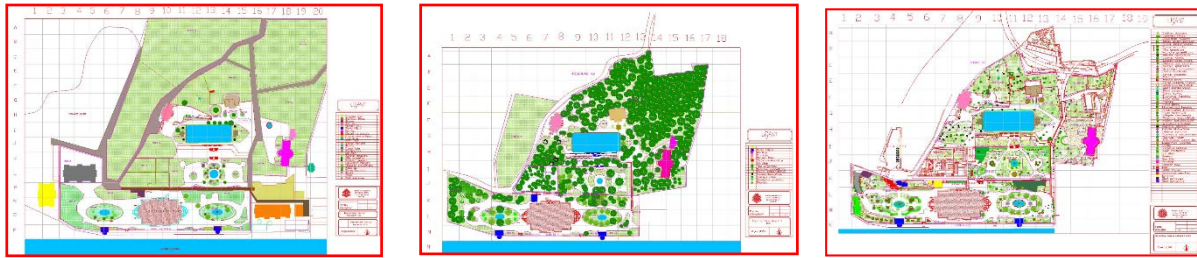
Figure 7. Beylerbeyi Palace Gardens, 1960 dimensioning sheet (Original 2016)

Figure 8. Beylerbeyi Palace Gardens, the dimensioning sheet of the construction period (original 2016)

Figure 9. Beylerbeyi Palace, current settlement plan and dimensioning sheet (Original 2016)

In the assessment of the present state map sheets of Beylerbeyi Palace Gardens, the interim period sheets (1960), and the restitution sheet of its construction period (restitution sheet), it was determined that the area undergone significant changes in general sense in terms of its size and green area ratio (Table 9). In
